**CONNECTICUT RIVER BASIN
LUDLOW, MASSACHUSETTS**

**NASH HILL RESERVOIR
MA 00550**

PHASE I INSPECTION REPORT NATIONAL DAM INSPECTION PROGRAM

OCTOBER 1980

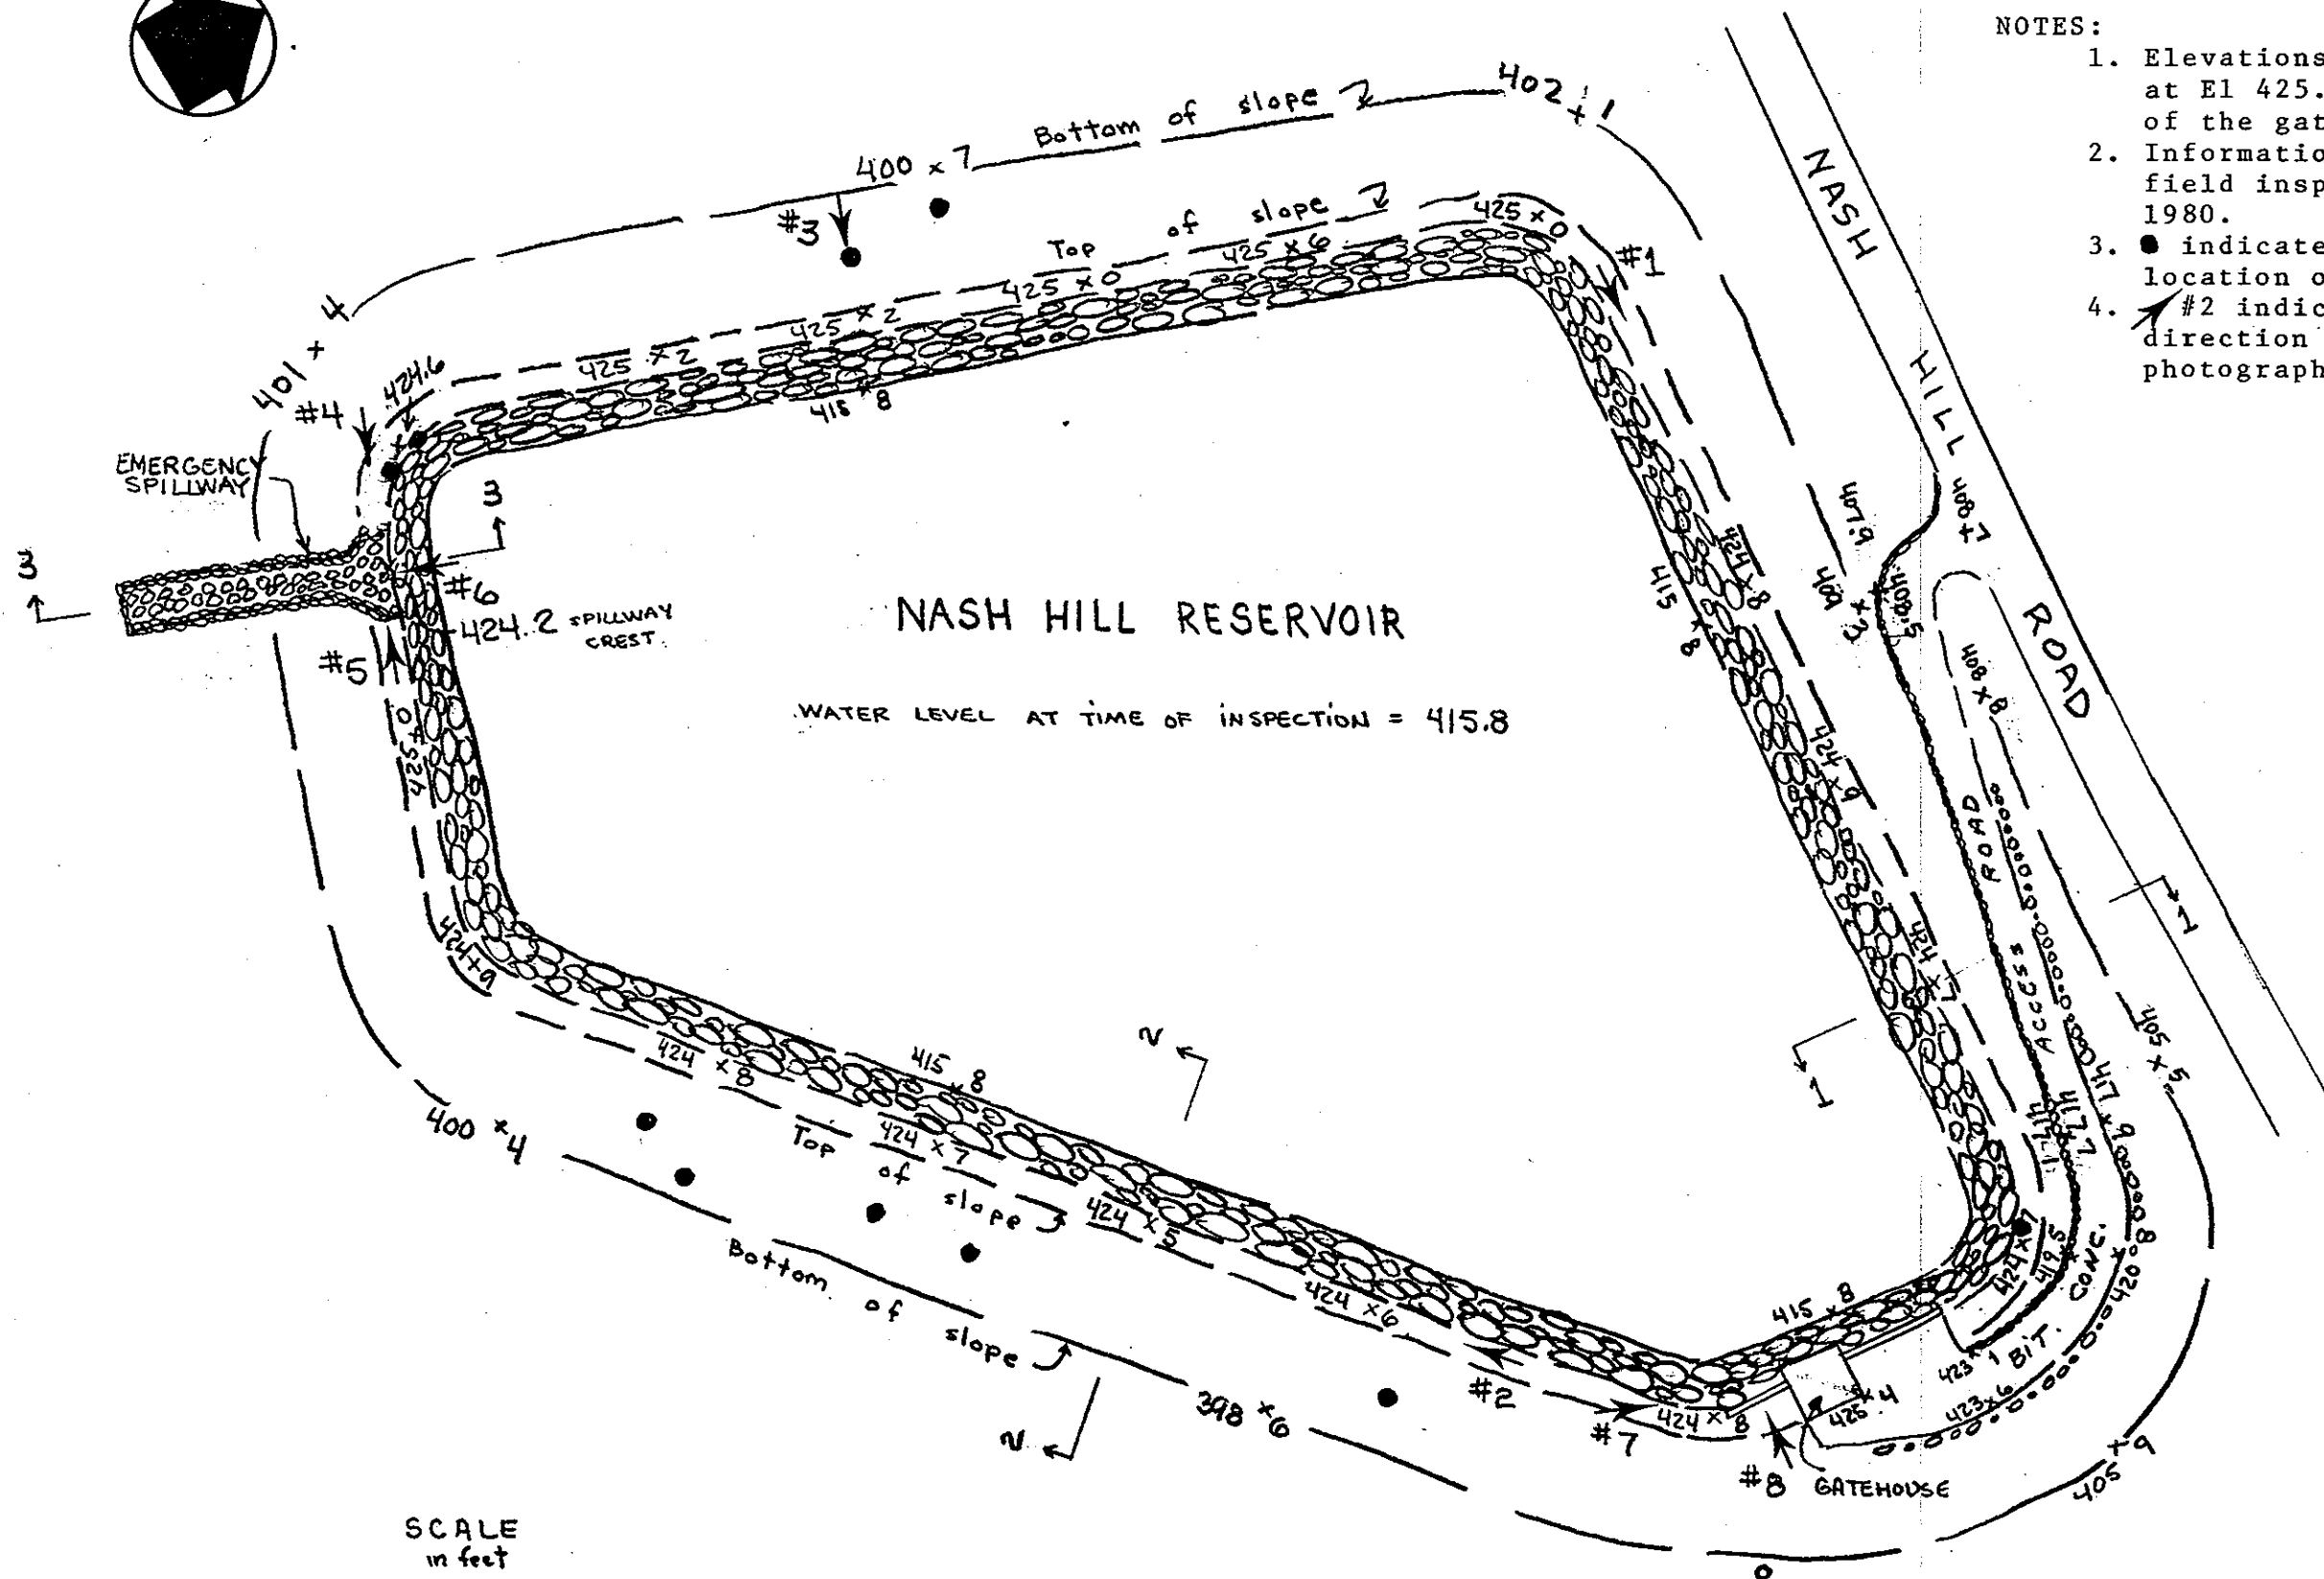
The most notable deficiency at the site is the presence of animal burrows on the top and downstream slope of the embankment. The burrows are 5 inches in diameter and generally about 1 foot deep, but at least two burrows are greater than 3 feet deep (see Photo No. 3). A total of 10 burrows were located, mostly on the southeast, south, and west sides of the reservoir (see Figure B-1). This condition has been cited in previous inspection reports and has reportedly been repaired in the past.
